The Road Inventory of Hakalau Forest National Wildlife Refuge Hilo, HI

Prepared By:
Federal Highway Administration
Central Federal Lands Highway Division
April 2013

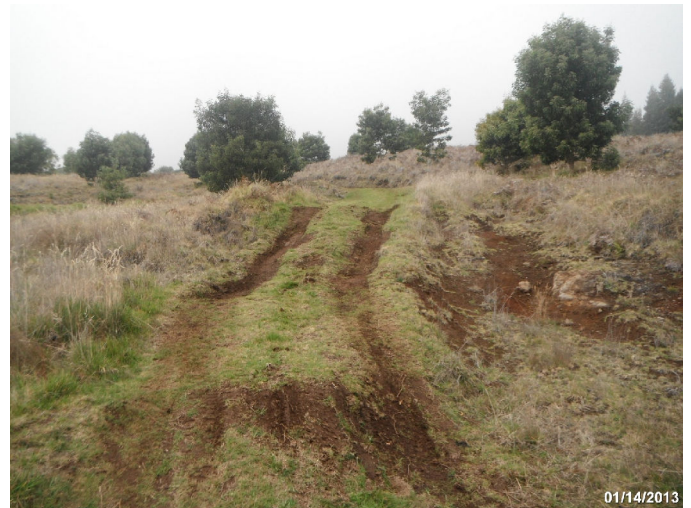
Photo: HAFO_C4_0870 Route: 402-001-0.28
Obstacle Road too rutted to continue

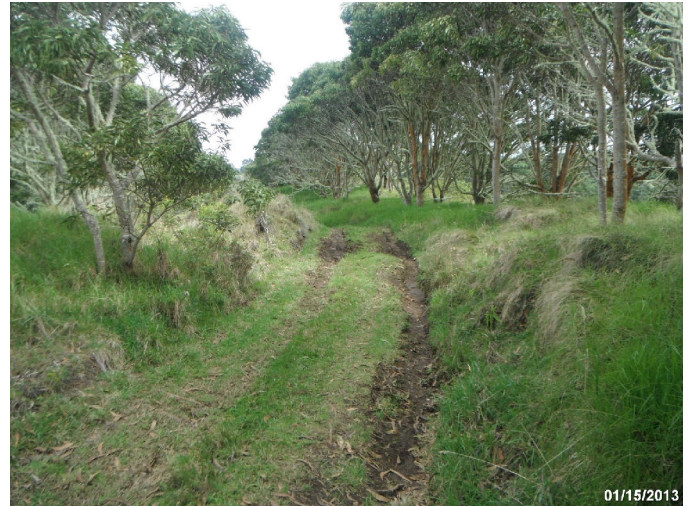
Photo: HAFO_C4_0912 Route: 410-001-0.11
Obstacle Road is too muddy to continue.

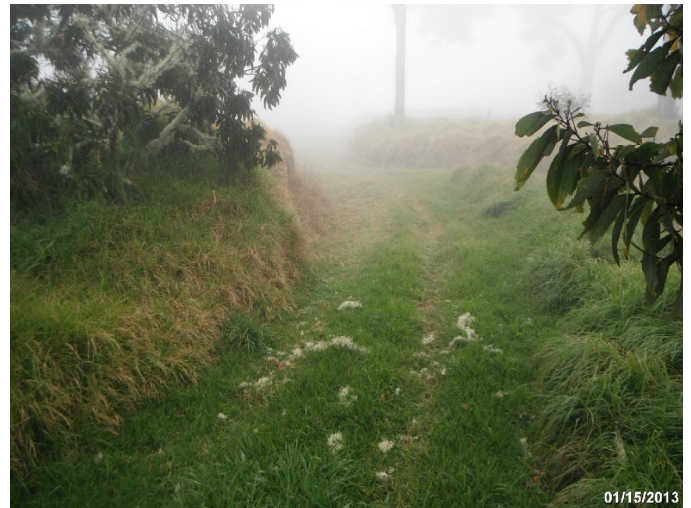
Photo: HAFO_C4_0931 Route: 411-001-0.18
Obstacle Too muddy and slick to continue
